"Is Your Medonic Hematology Analyzer Showing These Warning Signs? Check These Key Areas Now!"

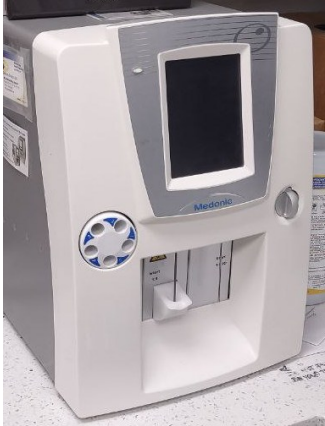
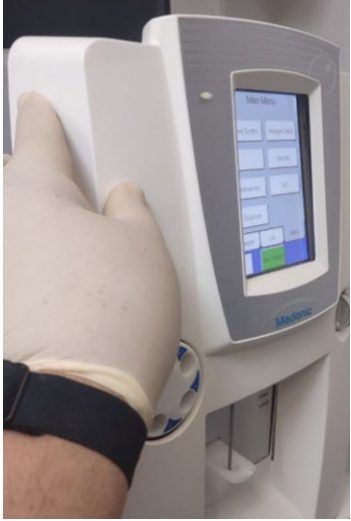
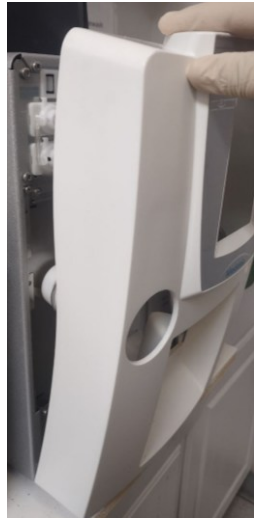
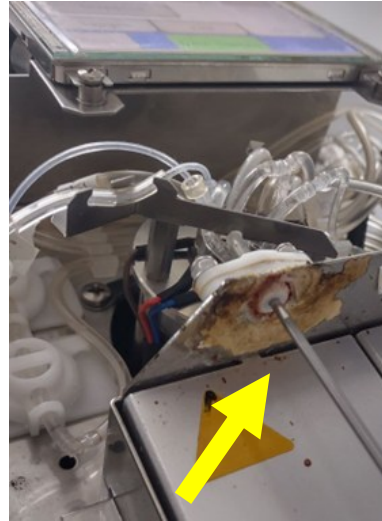
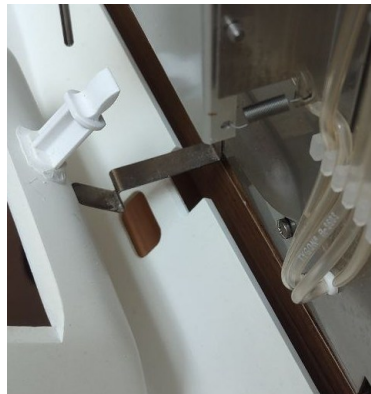
1. Firmly **grasp** the edges of the plastic front cover and apply steady, gentle pressure while **pulling** it toward you to remove it, as shown in the pictures.

2. Once the front cover is off, **inspect** the interior for leaks, debris, or salty deposits. **Pay close attention** to the areas indicated by the arrows.
